An archaeological and architectural evaluation of a fort at Qurayyah, Emirate of Fujairah

by Gareth Longden and Salvatore Garfi

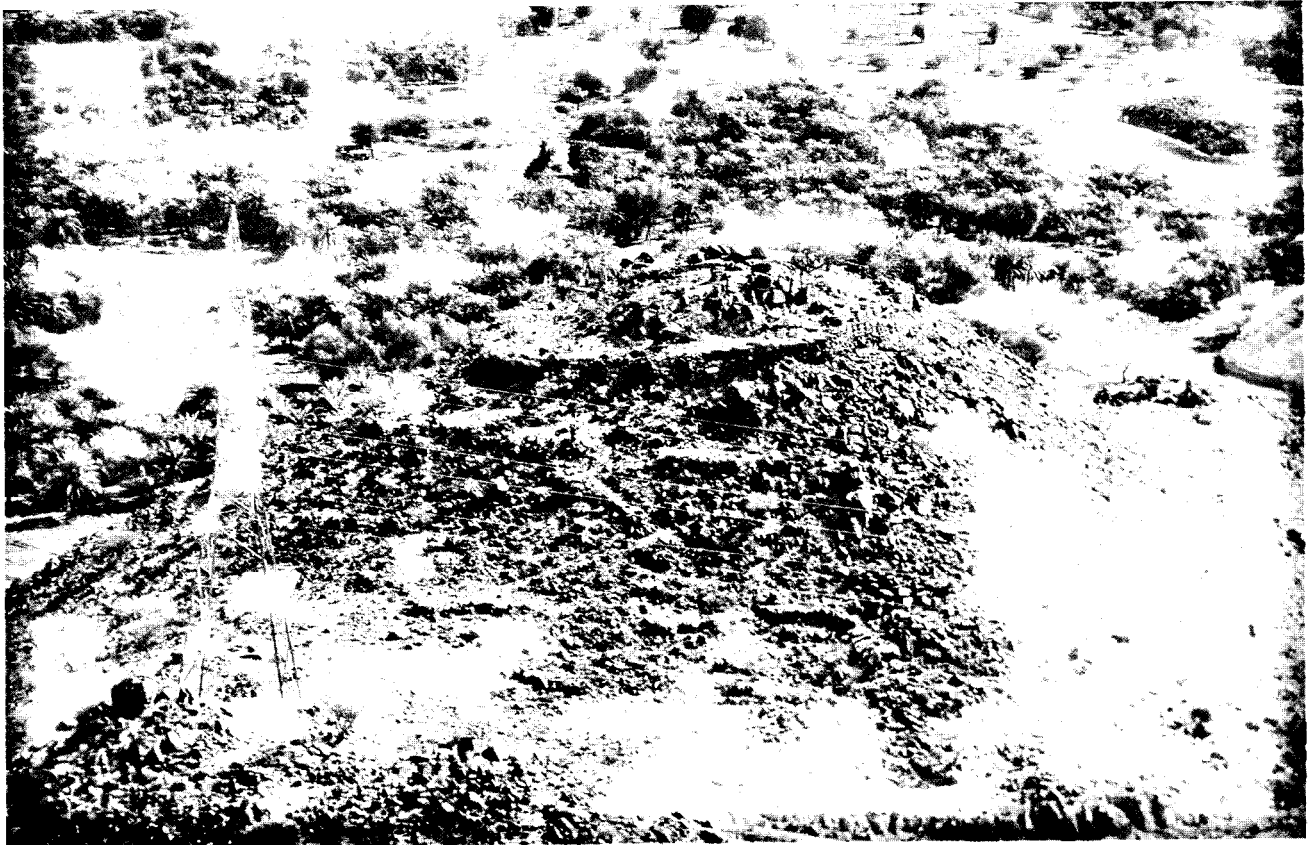
Plate 1: The *husn* at Qurayyah, from west, showing curtain wall and palm gardens beyond

The *husn* overlooks this plain and thus, ultimately, the entrance to both Wadis. The *husn* itself sits at the highest point of the spur, approximately 85 m above the surrounding coastal plain; its great size and the steepness of the slopes presents an imposing effect and provides an ideal defensive location (Plate 1; Fig. 1).

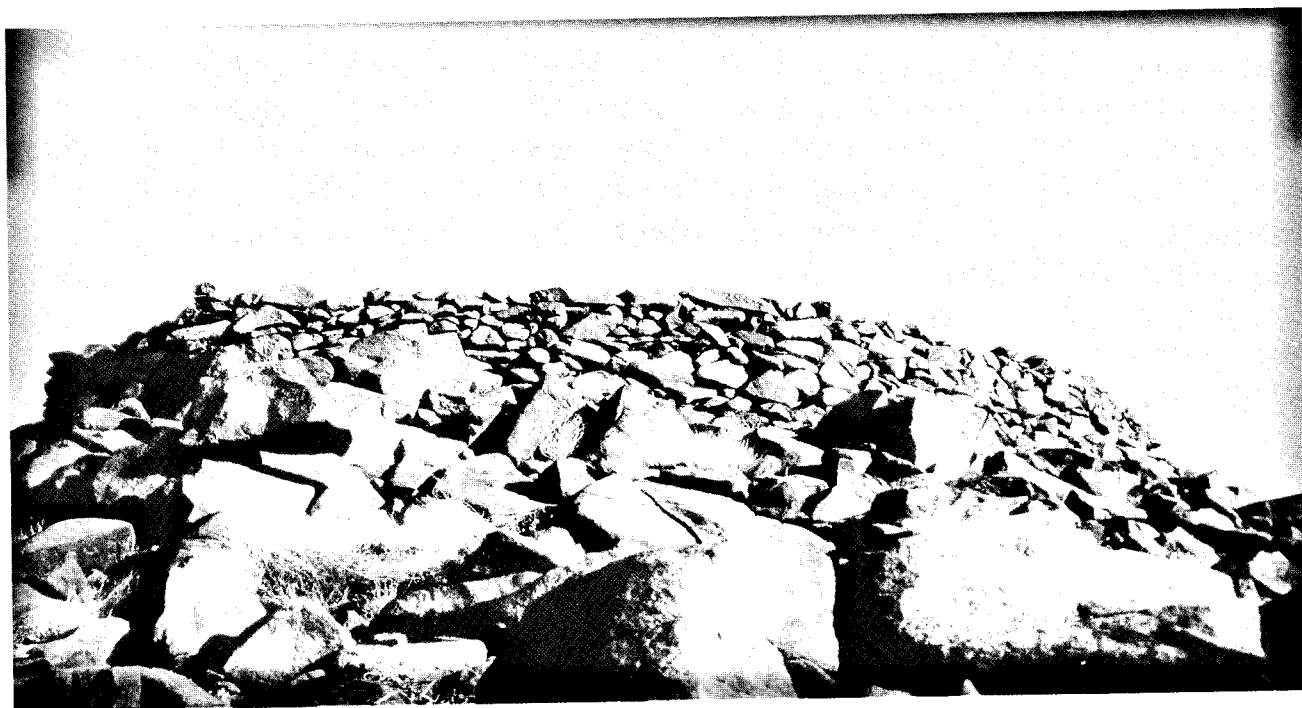
The main feature of the *husn* is a curtain wall which encompasses the summit of the hill (*Plate 2*). The space enclosed by the curtain wall has two distinct levels; a lower level immediately behind the wall and a second much higher area on the very summit of the hill. The area immediately behind the wall is narrow, rarely more than 2 metres in width; it is in this narrow area that the rooms within the *husn* are found. Behind this narrow stretch of level ground is a rock outcrop, approximately 3 metres higher, which forms the highest point of the hill. It is here that the cistern and the ephemeral remains of two other rooms are found.

The scale of the structure and the investment of labour in its construction is deceptive. The wall is approximately 240 metres in length and encloses an area that is approximately 3,500 sq.m. The wall in many places is over 3 m. high and is often over 1.5 m. wide. Some of

the individual boulders incorporated within the wall are over 1 sq.m. and weigh several tons. The investment in labour involved in creating such a structure belies its apparent simplicity and emphasises the important role that the building fulfilled. The curtain wall itself is made of roughly coursed stones that were originally bonded with an earth mortar. In many places, however, this bonding has dried out and blown away to the detriment of the stability of the wall.

Plate 2: The curtain wall on the west side of the *husn*

Similarly, the building of a new road up the Wadi Safad has led to extensive destruction of archaeological features, including a Late Islamic settlement (Longden and Garfi, 2000). The *husn* at Qurayyah has only just escaped destruction following the erection of an electricity pylon to the west of the site. The outlying parts of the site have, however, been affected. The long term preservation of the *husn* must be in question, and unless some stabilisation of parts of the structure is undertaken more deterioration must be expected.

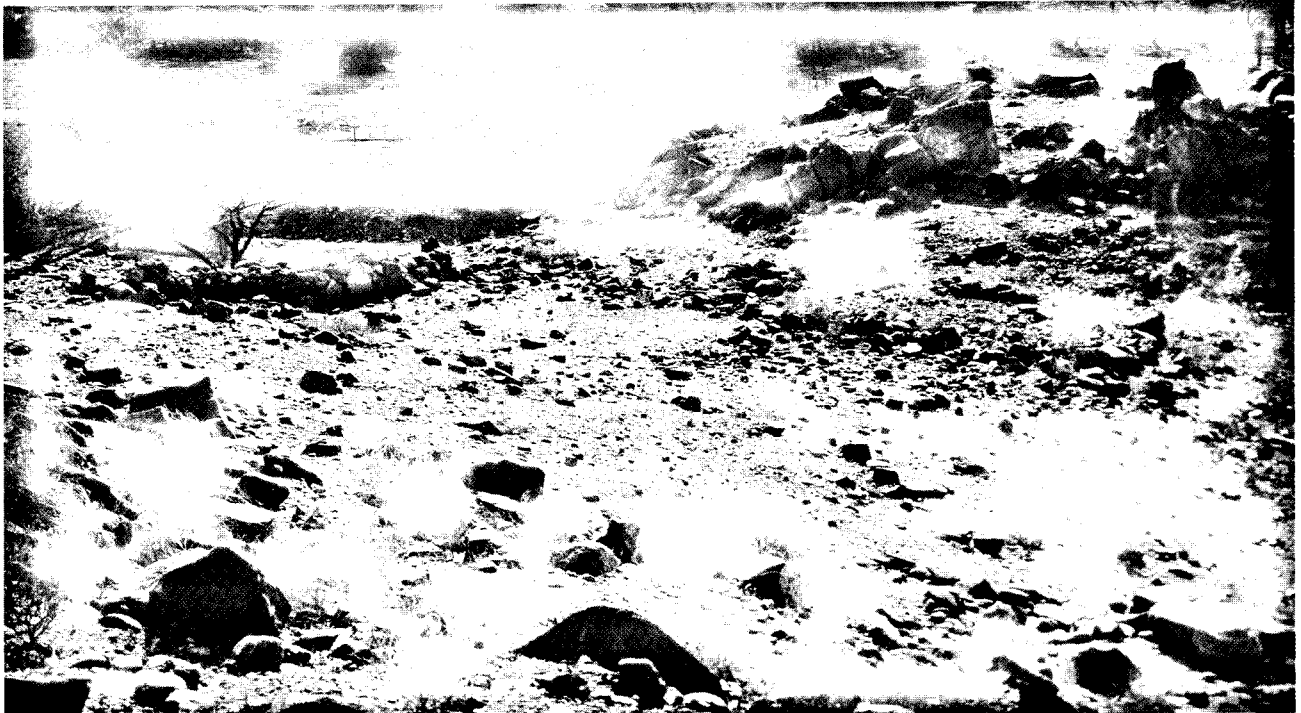
The mosque (Plate 4) lies to the east of the *husn* in a saddle of the hill between the main summit and a lower outcrop. The mosque is now ruined and a few courses of stones are all that remain. It is likely that this was an open summer mosque which was originally 13 metres by 7 metres, it stood alongside the remains of two other rectangular buildings. Immediately to the east of the mosque the secondary summit provides an excellent location for a small watch station within a roughly circular area.

Plate 4: Remains of the open air mosque at *Husn* Qurayyah, seen from the west
